Restoring a... Georgian desk

Chris Tribe repairs the flap, replaces cockbeading, restores the sides and sorts out the rail jointing

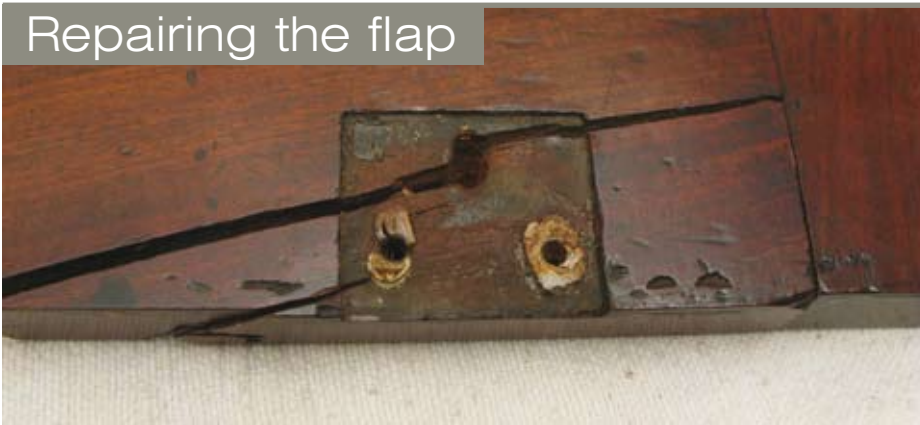
1 Damage to left hand of flap; note worn screw holes

The flap had broken at the hinge on the left and the hinge had broken from the interior on the right. There had been a previous breakage at this point – repaired with a nail, *photo 1*. This meant that the break was not clean so the repaired fit would not be perfect.

After removing the nail the broken piece was carefully cleaned of old glue using meths and warm water, then glued and clamped into place.

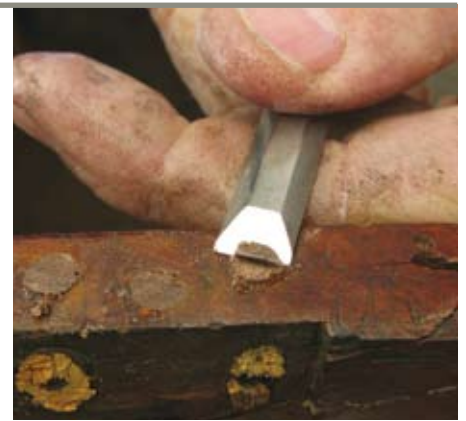
2 Trimming off the dowels inserted to strengthen repair to left of flap

One of the hinge screw holes was on the line of the break so there was a danger of the repair being weakened when the screw was replaced. All the screw holes were badly worn and had been plugged, so 6mm dowels were inserted from the edge of the flap to coincide with the position of the screws and then trimmed off with a chisel, *photo 2*.

This helped to stabilise the repair and gave more for the screws to bite into than inserting a dowel into the screw hole. When in position the edge of the flap is angled downwards, so the dowels are not evident.

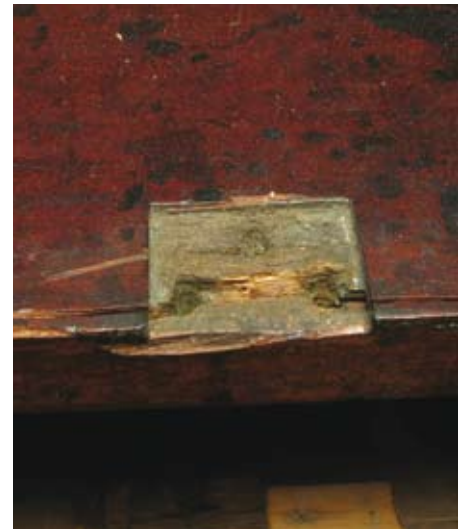
At the other hinge point the damage was to the interior. The break had occurred at the line of the two front screws of the

hinge, breaking away the 4mm-thick mahogany lipping and some of the oak substrate, *photo 3*.

3 Damage to hinge point at right side

I decided to recess a new piece of oak underneath the veneered surface. This meant using the router running on the edge of the board, a tricky operation requiring packing and jiggging.

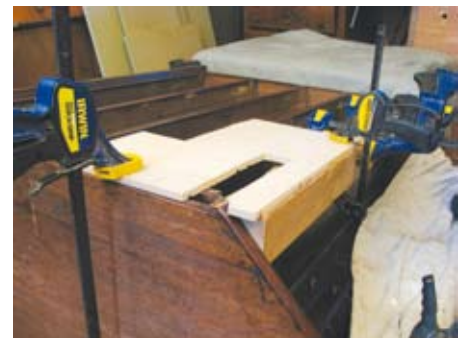
4 Preparation for cutting recess to repair broken hinge area

To provide a stable surface for the router to run on, a piece of 9mm MDF with a hole in it to provide access to the area to be cut was clamped to the front of the bureau, *photo 4*. A replacement piece was cut with angled ends and fitted by trial and error to the cleaned up recess, *photo 5*. Because of damage round the screw holes the area around them was replaced, *photo 6*.

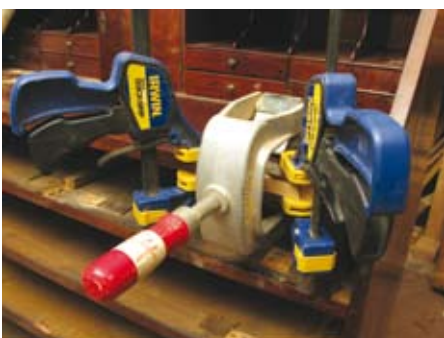
5 Clamping on the replacement

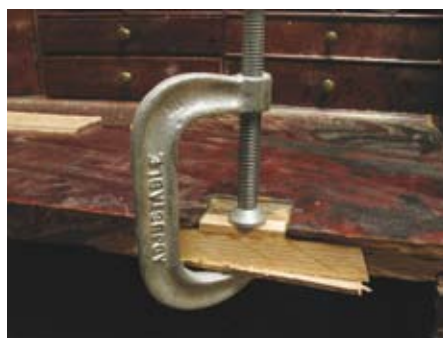
6 Clamping additional piece around screw area

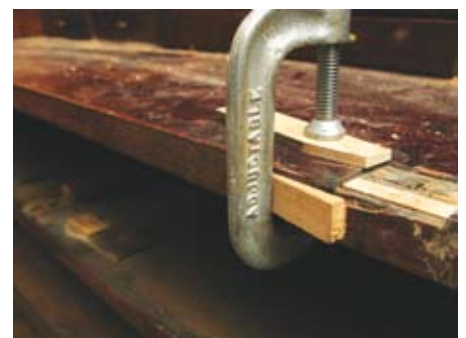
7 Improvised edge clamp

Some of the substrate behind the 4mm lipping had broken away so I ensured that the piece fitted snugly around the previously fitted oak piece, clamping with a small G-clamp and an oak wedge, *photo 7*, then replaced a small strip of veneer adjacent to the hinge.

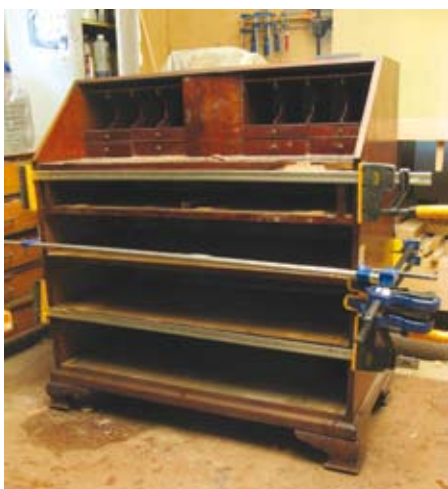
8 Clamping the injected rail joints

The fit of the drawers was slack, vertically due to wear in the drawer bottoms and running surfaces and horizontally due to the sides detaching from the front rails.

The rails are only retained by quite short housings into the side pieces. I decided to inject animal glue into the joints and clamp. Using a 1.5mm drill bit and choosing an unobtrusive location I drilled into the joint until I felt the drill hit a void. Animal glue was injected via syringe and needle into the joint and the sides clamped, *photo 8*.

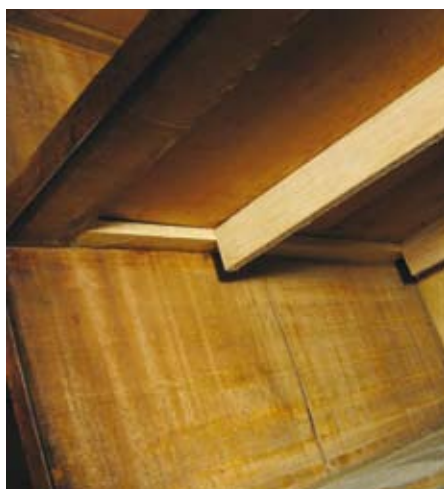
9 Kicker being glued in place; sprung lathes hold it in place

An issue probably related to the loose side joints was a missing kicker on one of the housings between the dust boards and the side. This was shown by the dust board dropping in its housing, thus increasing the slackness of the drawer, and was corrected by fitting a 25mm-wide piece of oak into the housing below the dust board. The piece was glued and held using sprung lathes, *photo 9*.

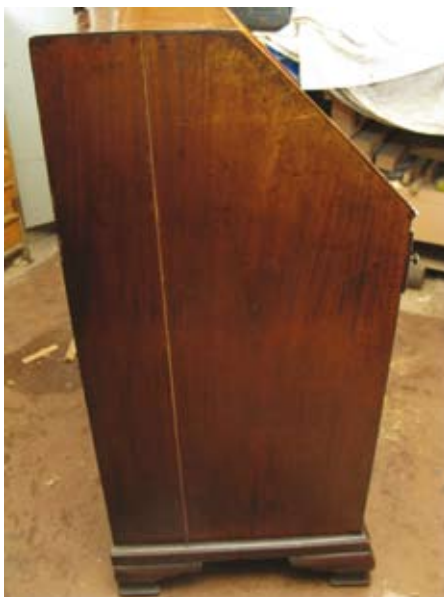
The left side had a vertical fairly straight split from top to bottom where the boards had parted.

10 Vertical fillet fitted to left-hand side

After cleaning any debris and wax from the opening a fillet of mahogany was planed up to fit, catering for the slight taper from top to bottom. The fillet was also tapered slightly in width to gently wedge into the split. The fillet was glued and tapped home, leaving a small amount standing proud to be removed with block plane and scraper after the glue had set, *photo 10*.

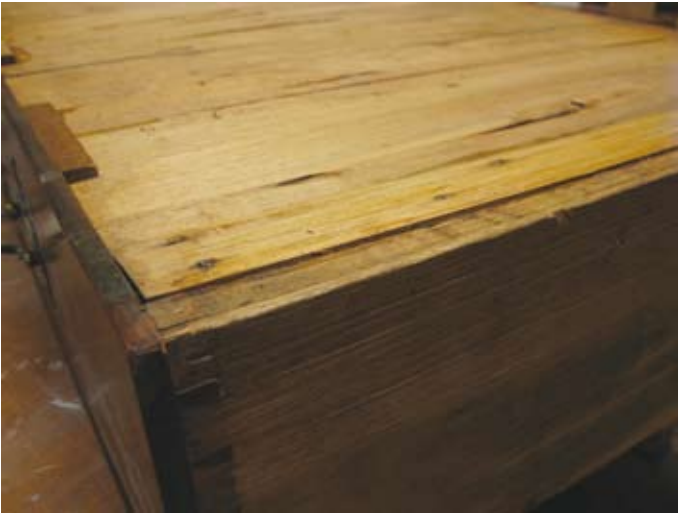
Because the drawer sides were only 7-8mm thick and the bottoms were much thicker than that, there was considerable wear and break up at the bottom of the sides. To remedy this, a previous restorer had nailed some pine runners to the bottom, *photo 11*. The pine had worn to allow the nails to excavate grooves in the runner boards, *photo 12*, causing the drawer stops to wear wide grooves in the bottoms, *photo 13*.

11 *Worn and damaged drawer sides and nailed runner*

To remedy these problems I decided to fit oak fillets on the dust boards and to replace the bottoms of the drawer sides in order to provide good running surfaces for the drawers and lift them up to prevent wear to the bottoms.

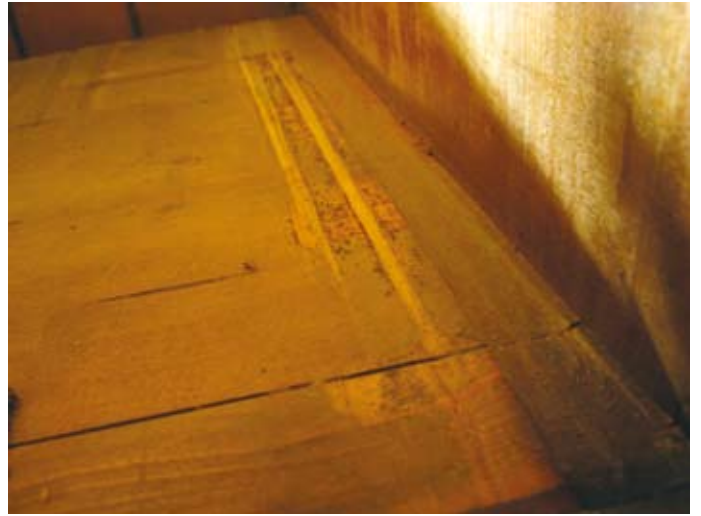
12 *Grooves worn in dust boards by drawer runners*

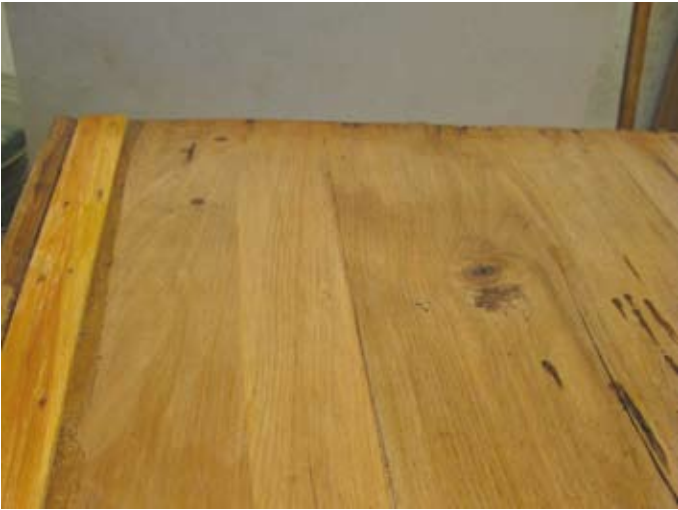
13 *Damage to drawer bottoms from rubbing on stops*

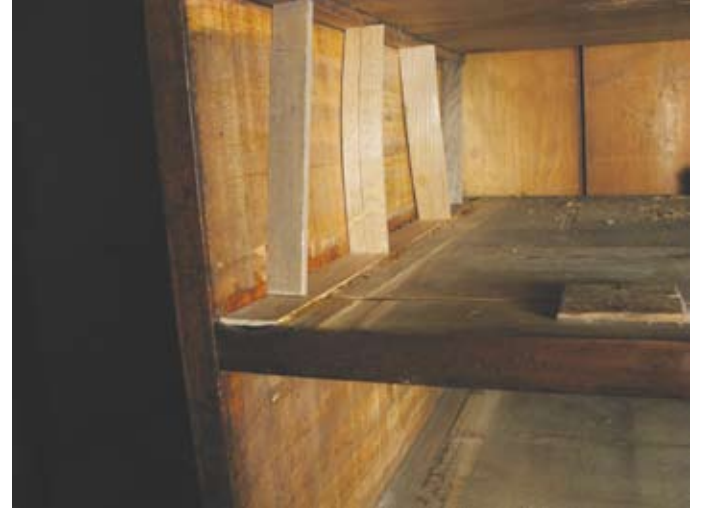
14 *Fillet glued in place on dust boards using sprung lathes*

Using a shoulder plane a groove was excavated next to the carcass side. To ensure a clean edge to the groove, a marking knife was used to cut the fibres at the edge, using the plane edge as a guide for the knife.

The groove was deepened until a flat bottom was achieved, about 3mm, and a 3mm fillet was glued into the groove and held using sprung lathes, *photo 14*.

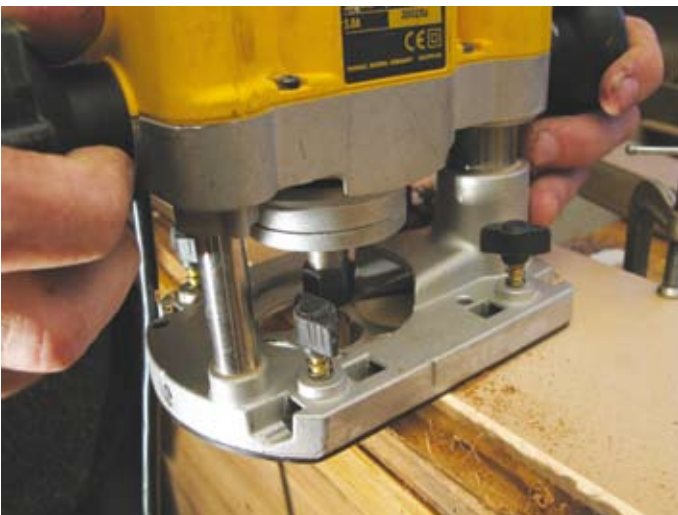
15 *Cutting bottom of drawer sides with router collar bearing against MDF straightedge*

The repair to the drawer sides required the removal of the worn or broken bottom parts, leaving a clean line for fitting a new piece, achieved by using a router with guide collar running against a straightedge of 9mm MDF clamped to the drawer side so that the edge was parallel with the top edge.

The cut was made with the collar bearing against the MDF, *photo 15*. The depth of cut depended on the amount of damage to the side, in effect cutting the side in line with the underside of the drawer bottom.

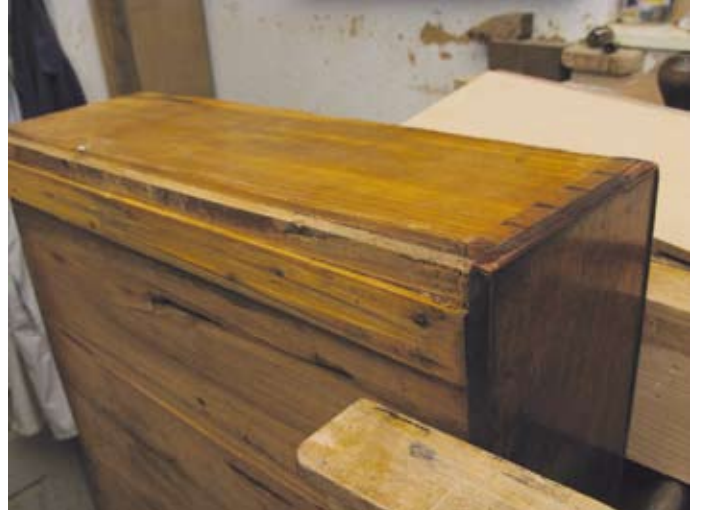
16 *L-shaped area removed from bottom of badly damaged drawer side*

A couple of the sides had damage higher up which required a shallower cut to remove an L-shaped area, *photo 16*.

Oak pieces were used to replace the cutaway sections and rebated pieces were machined, marginally oversize to allow for trimming to fit, to fit the cutaways. After gluing up the drawers were fitted.

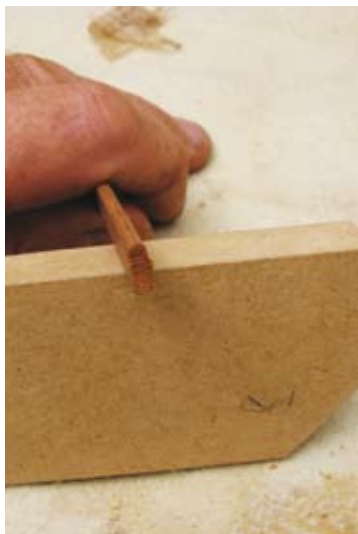
The 3mm thickness of the cockbead on this piece made it more prone to damage and the lower ends had almost no bead left. The rounding was formed using a block plane and abrasive paper, *photo 17*.

17 Replacement cockbead

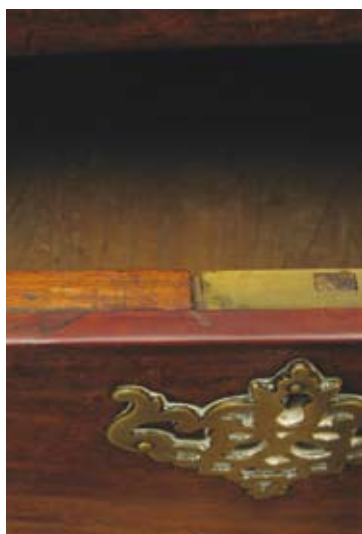
18 Cockbead repair around lock after refinishing

Damaged areas were removed and new bead spliced in, *photo 18*. I mitred the corners by making a jig from stock cut at 45° and clamped to a saw hook, *photo 19*.

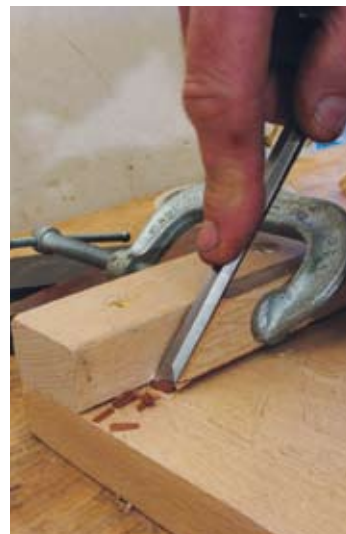
19 Makeshift mitre jig

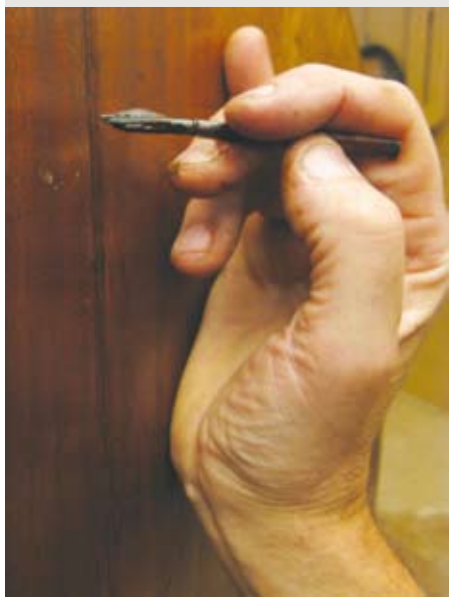
20 Colouring with a quill

Final colour matching was now possible using spirit stains and earth pigments mixed in a thin dilution of button polish and meths applied with a quill, *photo 20*.

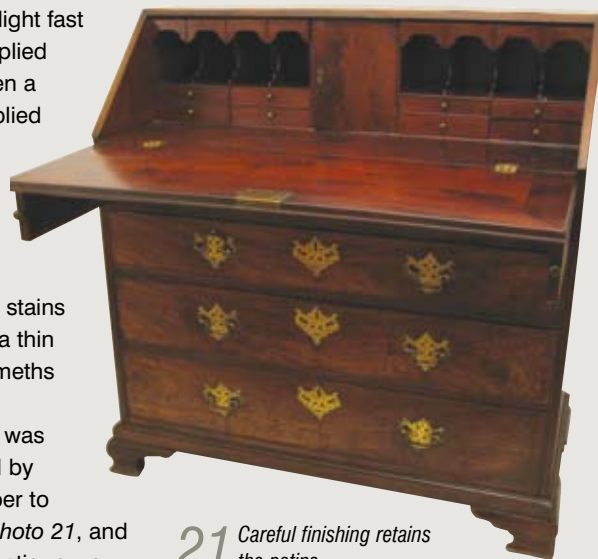
21 Careful finishing retains the patina

A coat of thin button polish was applied with the quill followed by more applications with a rubber to blend with the background, *photo 21*, and an application of mahogany antique wax
